Dowager's Return

A log of an eight-year metamorphosis of a New York 30 from her original gaff-rigged sloop design to a modern jib-headed yawl. Her owner says she "is as sound as a pre-Roosevelt dollar"; her mint condition belies her advanced age—fifty-nine years old!

Popular Boatng
May 1964

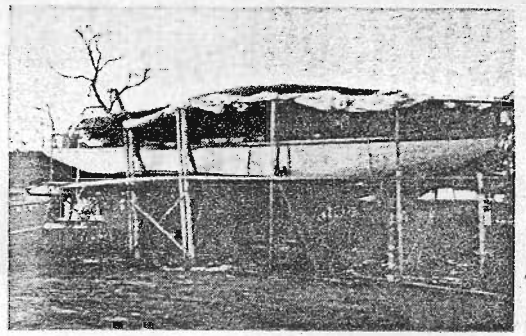
Great experiment of 1963 was the covering of *Cockatoo's* hull with Dynel. Bulwark was also added at the same time.

The Great Experiment of 1963—the Dynel sheathing—was also a success. When hauled on December 7th, *Cockatoo II* was as dry as a bone and those blasted garboard seams were no longer a problem. There was, however, one small 2'x2' patch of about nine bubbles, where the resin evidently remained uncured. A simple job to fix. There was no sign of working planks or seams, although there was a minor protrusion in some of about one or two thousandths. These will be sanded off without compromising the Dynel and when she is repainted no seams will be visible in her topsides.

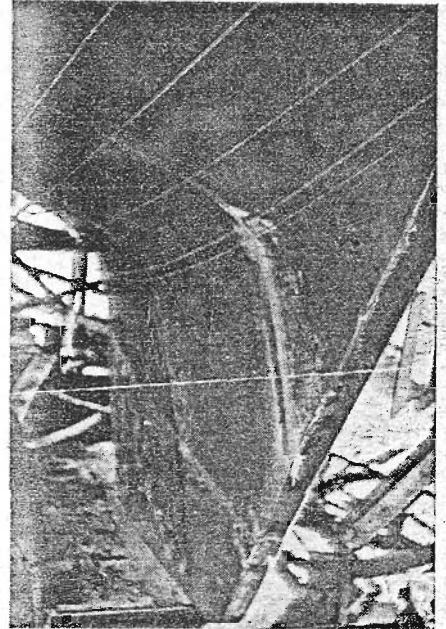
Seams permanently closed with wooden wedges, Dynel was applied in two layers.

The application was a three-man job. One mixed, two others applied the resin with rollers. It was found most convenient to wet the surface with resin before applying the cloth—essential, as a matter of fact, in the way of the lead. Bronze staples were used to tack the cloth in place temporarily, especially in the area at the turn of the bilge. The first layer was applied vertically working down from the top of the bulwark. The second layer was applied in longitudinal strakes. While butts were intentionally minimized, any overlaps were ground smooth—a tedious job, but necessary. We then proceeded to smooth up the whole surface, which was even more tedious.

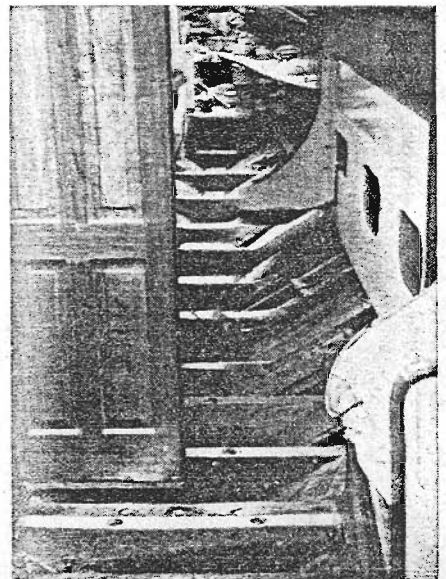
Rotting floors caused *Cockatoo II's* keel to rock slightly. Solution was installation of eight bronze sister floors, Monel fastened.

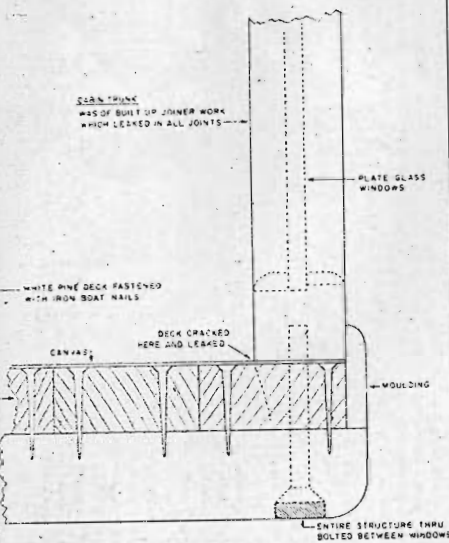
But she was leaking. She couldn't hold her caulking in her garboard. Perhaps the thrust of the mast was too great. Also, the cabin house had been racked over the years enough to leak and since the latter was less important but more irritating, rebuilding the cabin house became the primary winter project.

Original Herreshoff cabin house sides were secured to deck in above manner. In an older boat, this was a sure invitation to leaking.

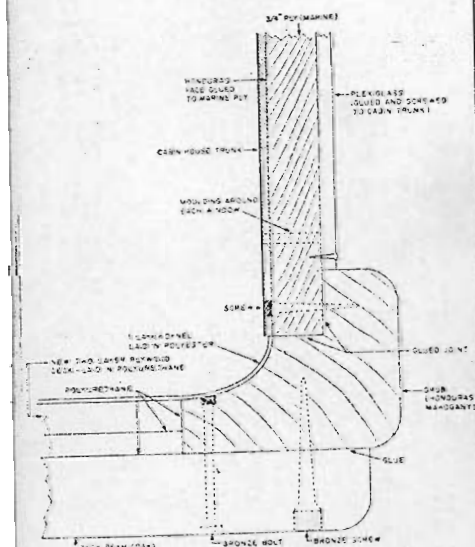
New cabin house sides, suggested by Major Smyth, employs mahogany "Grub", especially milled to fit all components.

was in good condition, we had only to rebuild the cabin house sides. This was accomplished by employing Major Smyth's suggestion of a "Grub" (see sketch). The new sides were made of 3/4" fir plywood, scarfed and glued to proper length and size, which were then glued—sandwich style—on either side of a Honduras mahogany plank. This was then slit down the middle, exposing the mahogany which became the outer face. The openings for the windows were then cut in, long strips of Plexiglass were glued and screwed with Monel to the inside face and the completed cabin house sides were in turn glued and screwed to the "Grub" which had been especially milled to shape. This formed two longitudinal girders which were bolted to the deck

beams. New corner posts were fitted, the forward and after faces of the cabin trunk refitted, and the top was dropped back in place. Nat Herreshoff is supposed to have scorned the use of plywood, but I think this is one application where we were one up on him.
